SUBJECT: START 3, EPA Region 8, Contract No. EP-W-05-050, TDD No. 1008-13
Trip Report, Upper Animas Mining District, Silverton, San Juan County, Colorado

TRIP REPORT
Upper Animas Mining District
Silverton, San Juan County, Colorado

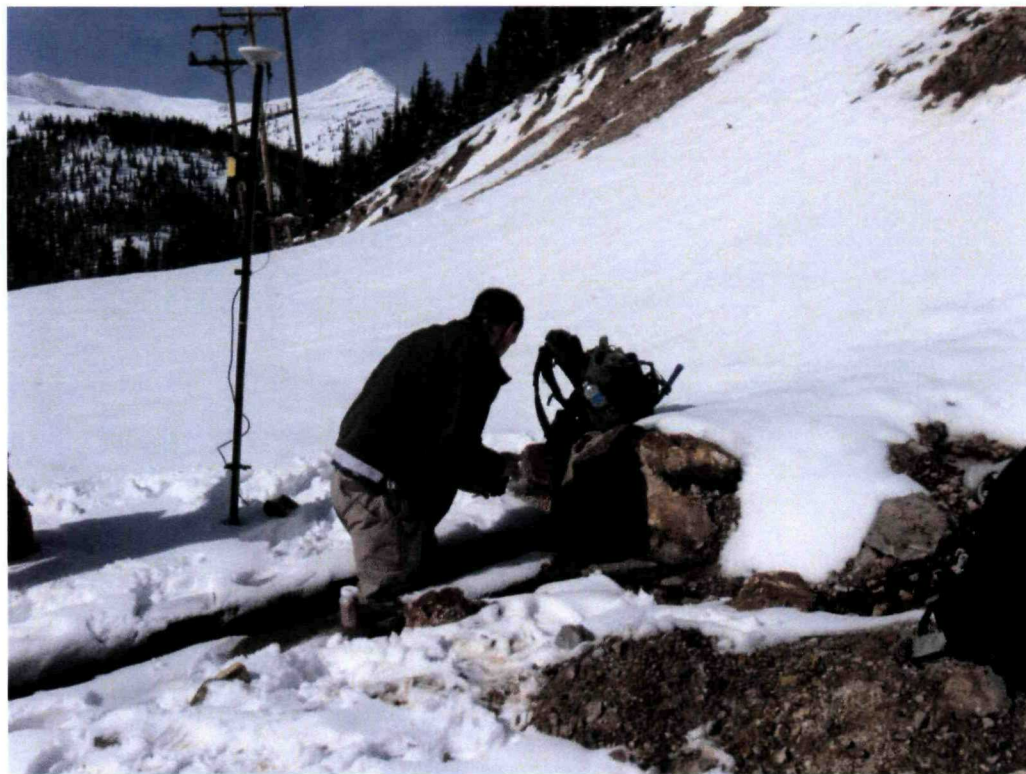
Photo 37
North fork of Cement Creek – flow is low and area is mostly frozen over.

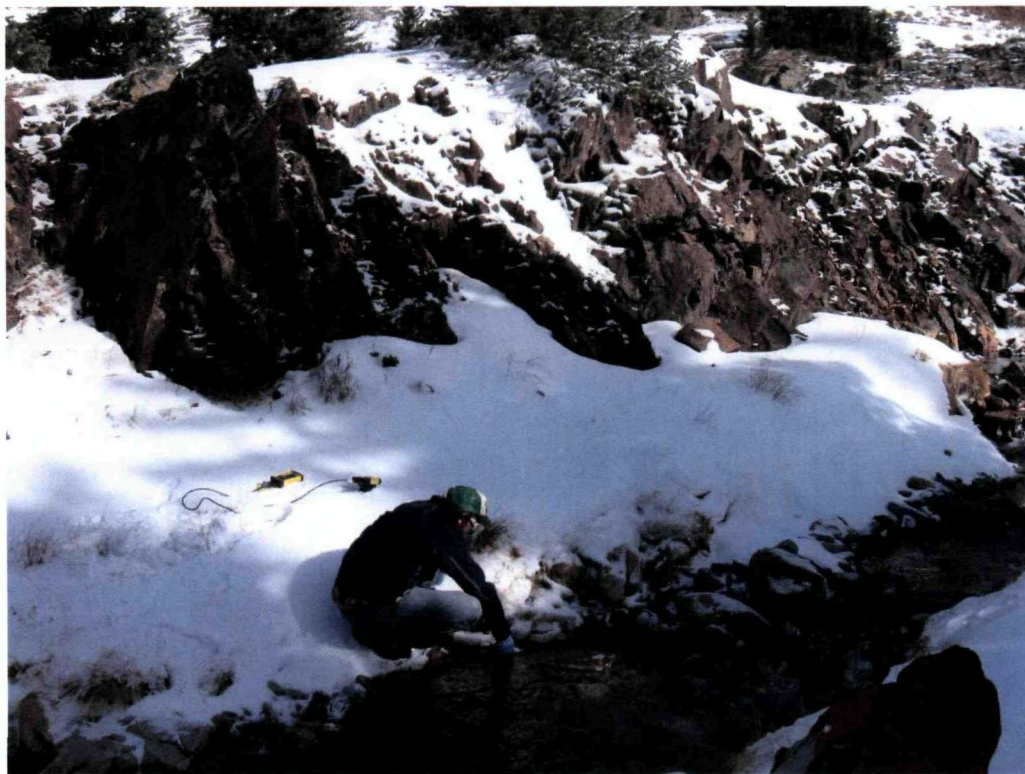
Photo 51
Red and Bonita waste piles.

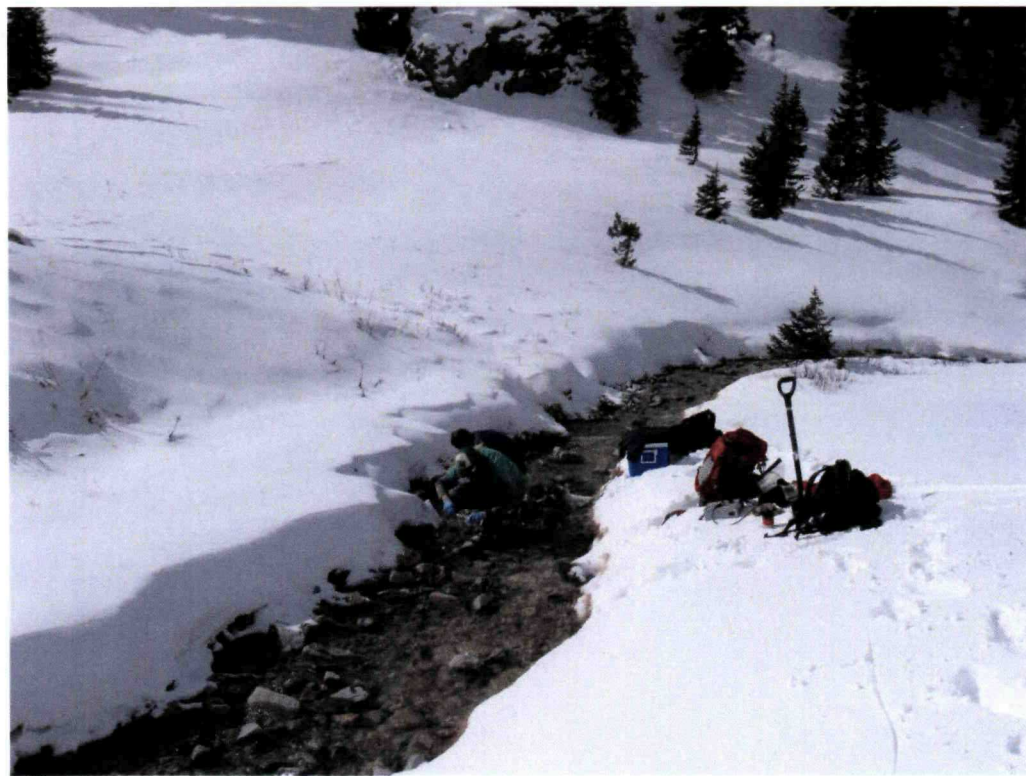
Photo 55
Seepage from the toe of the Mogul North waste pile.

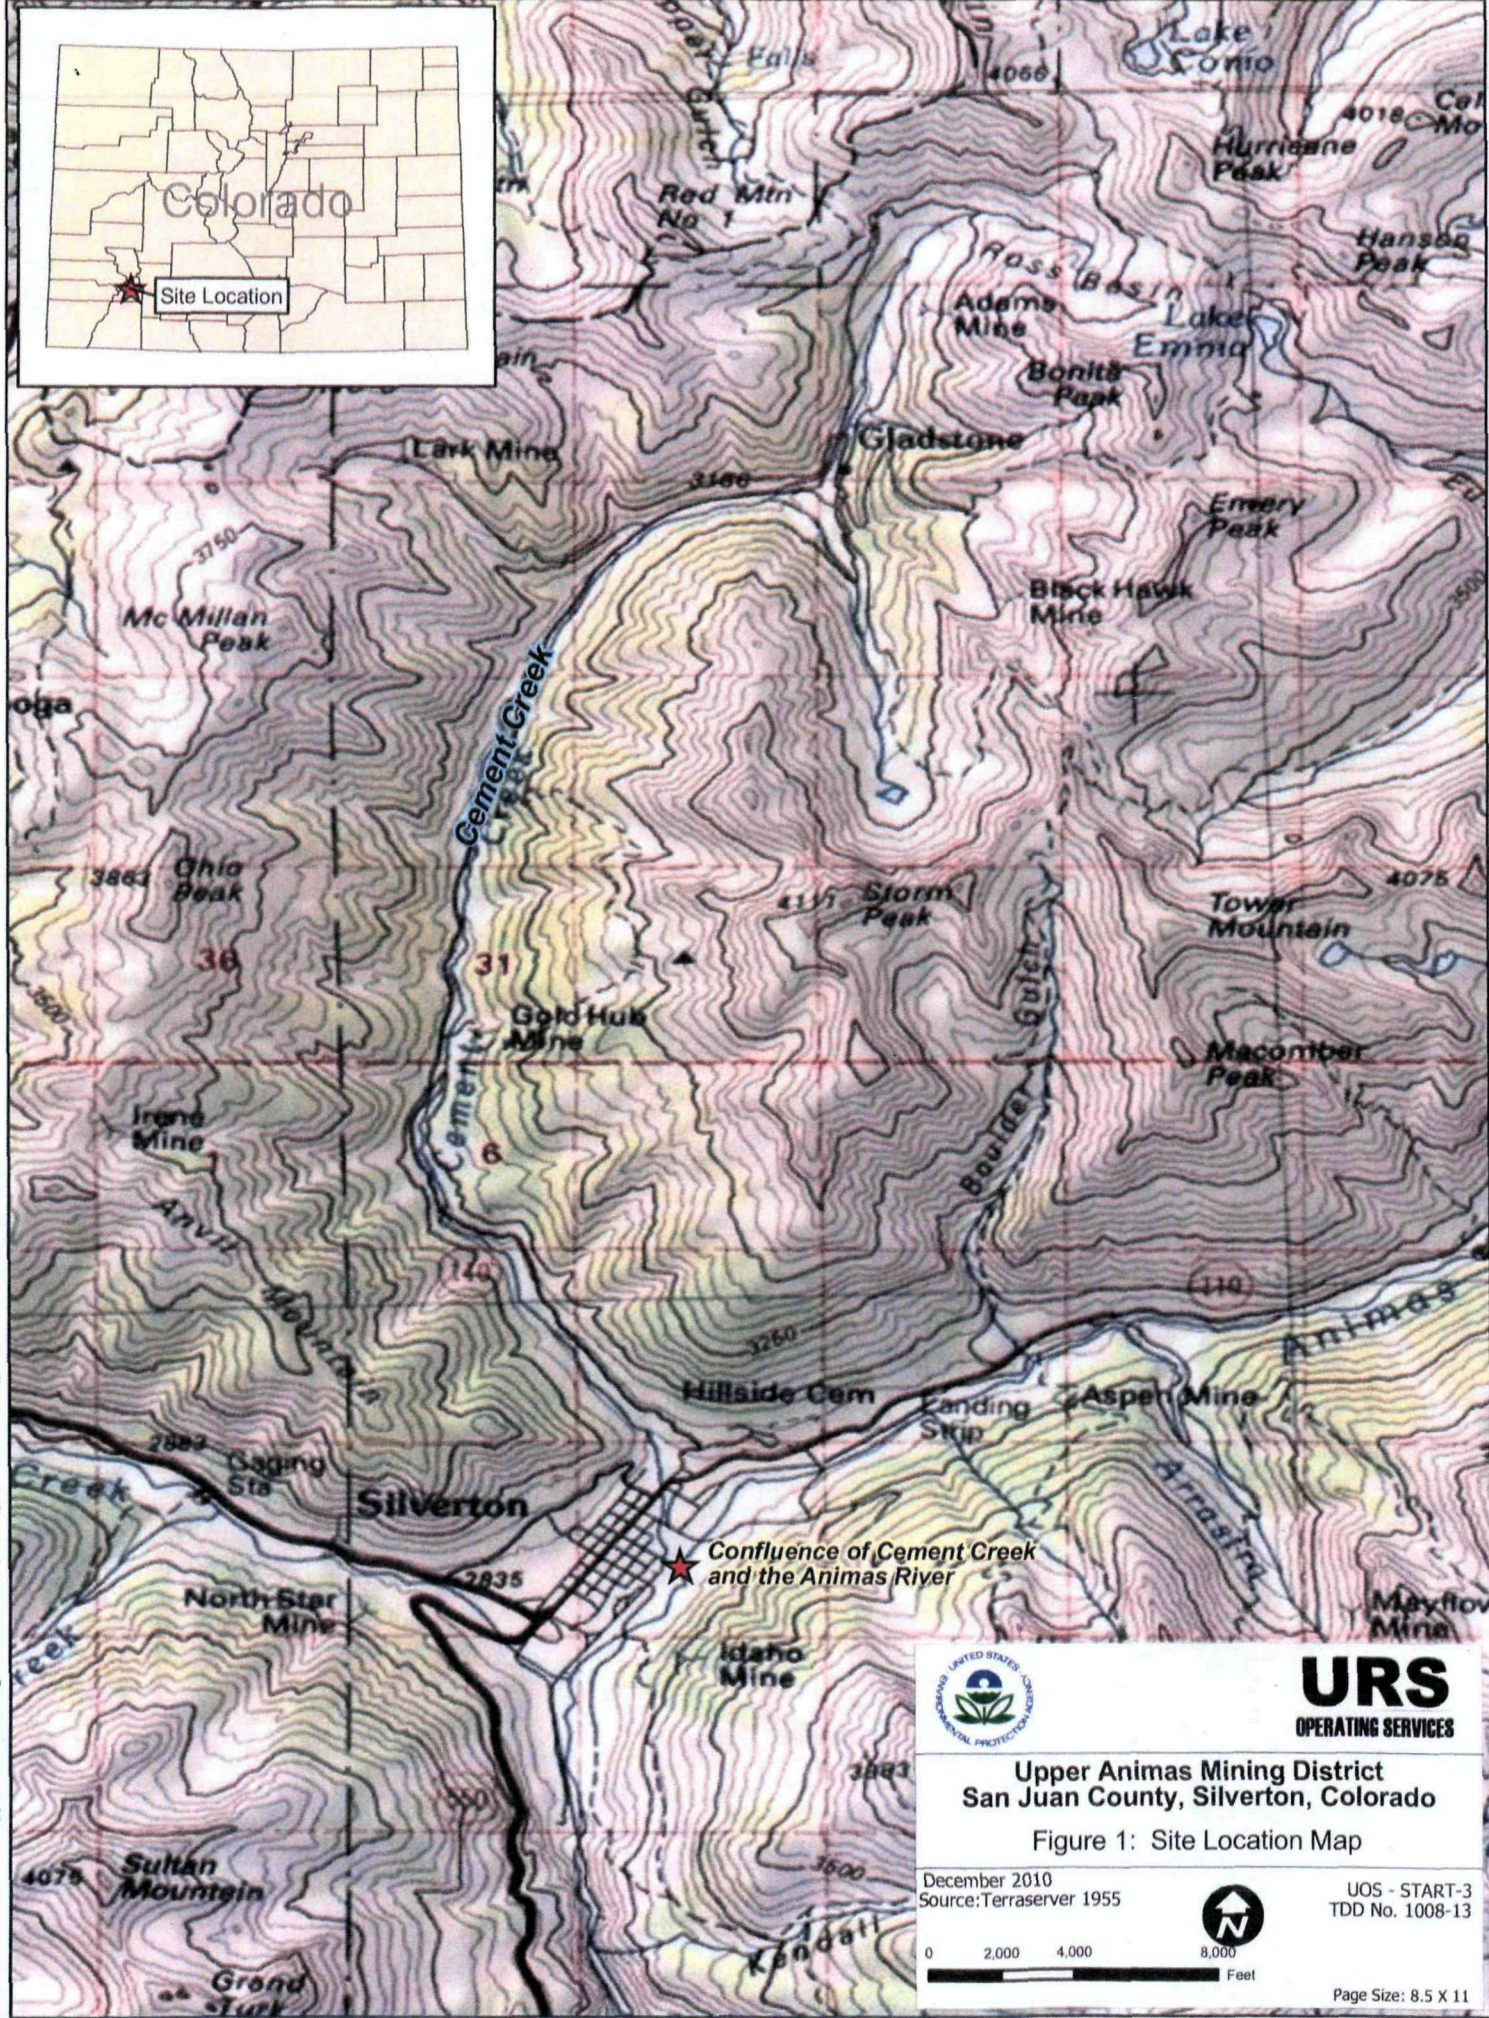
Photo 74
Steep slope of Gold King 7 Level waste piles.

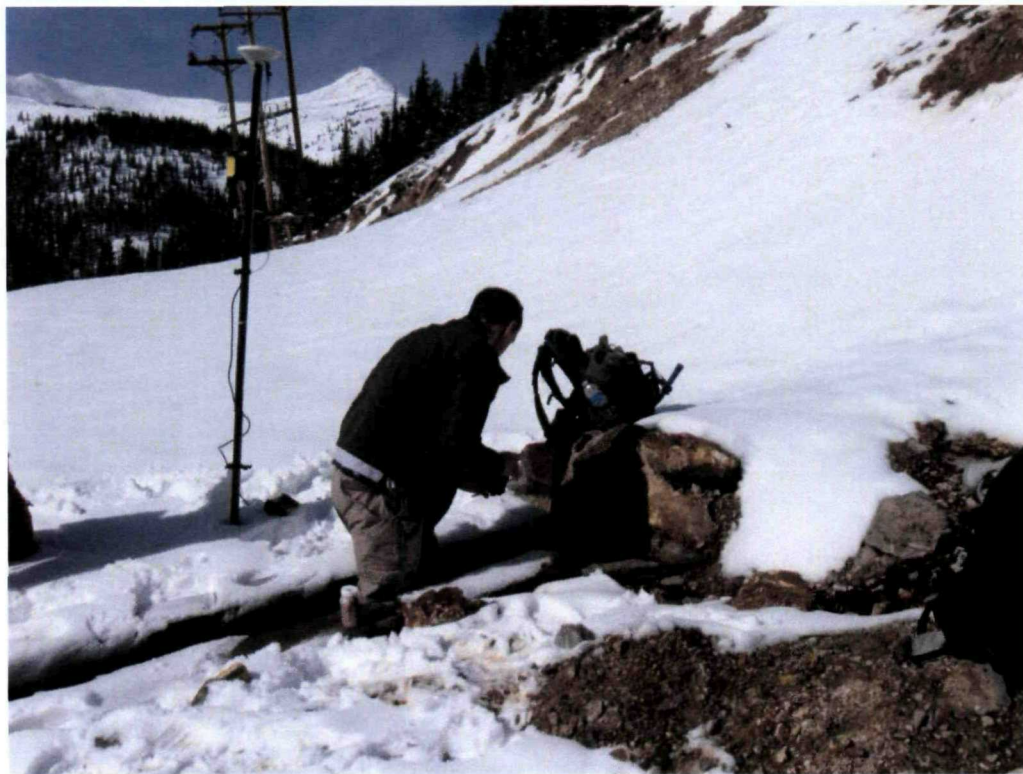
Photo 37
North fork of Cement Creek – flow is low and area is mostly frozen over.

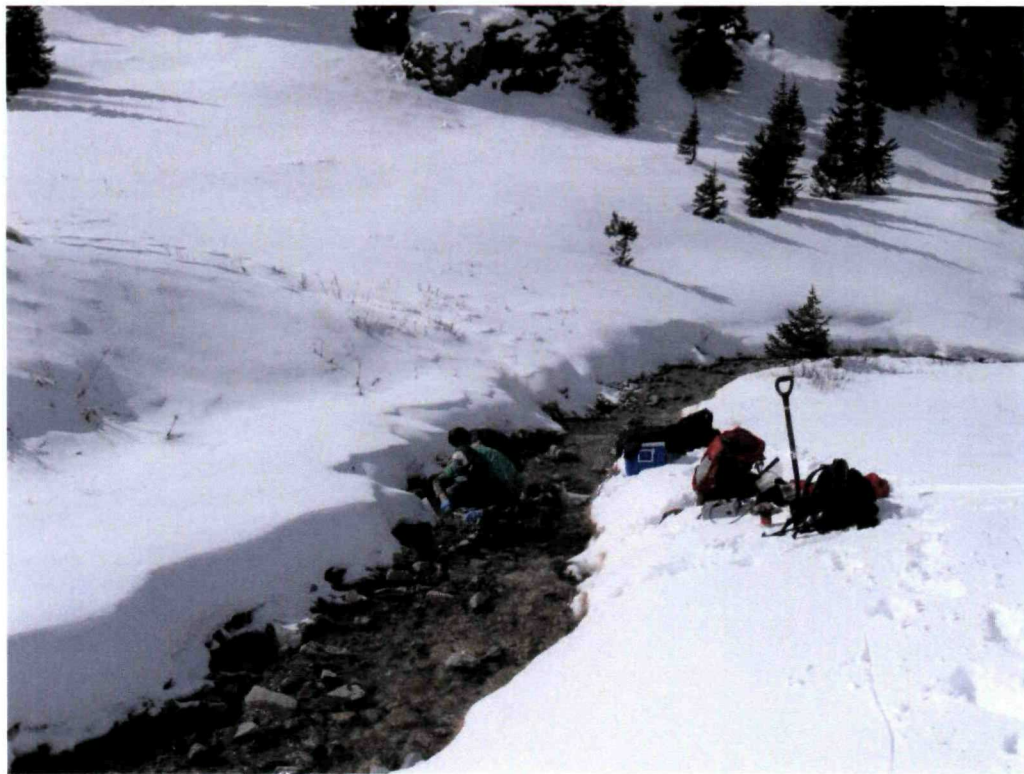
Photo 55
Seepage from the toe of the Mogul North waste pile.

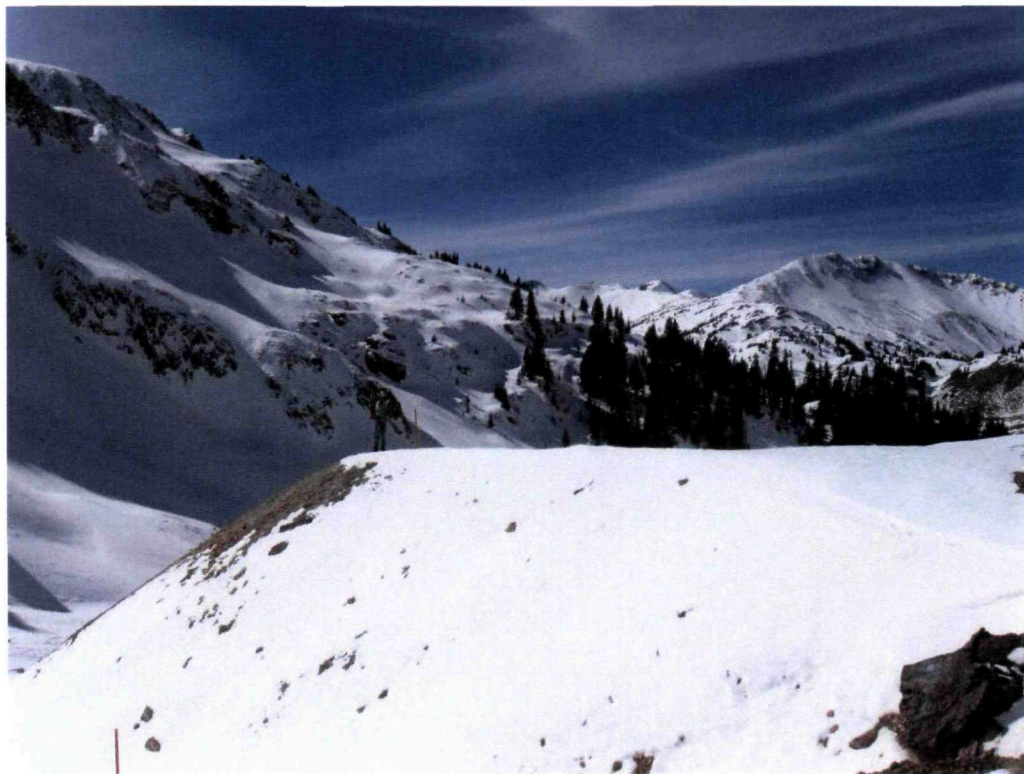
Photo 63
Grand Mogul Mine and Mogul Mine stope waste piles.

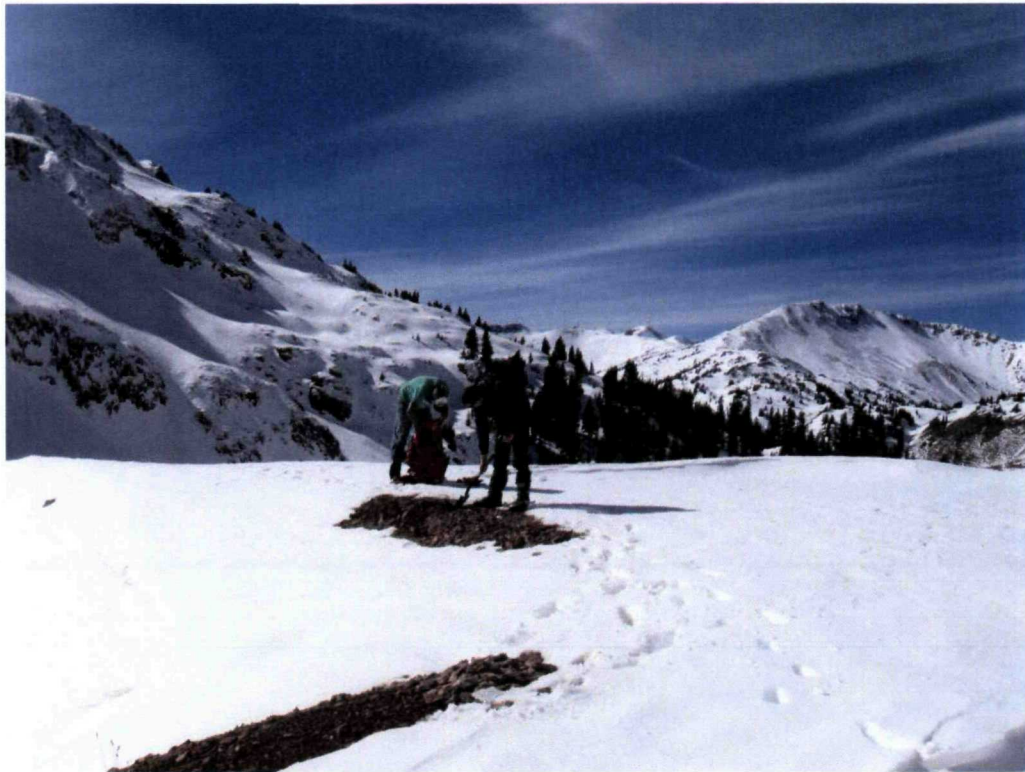
Photo 64
Grand Mogul Mine easternmost waste pile.

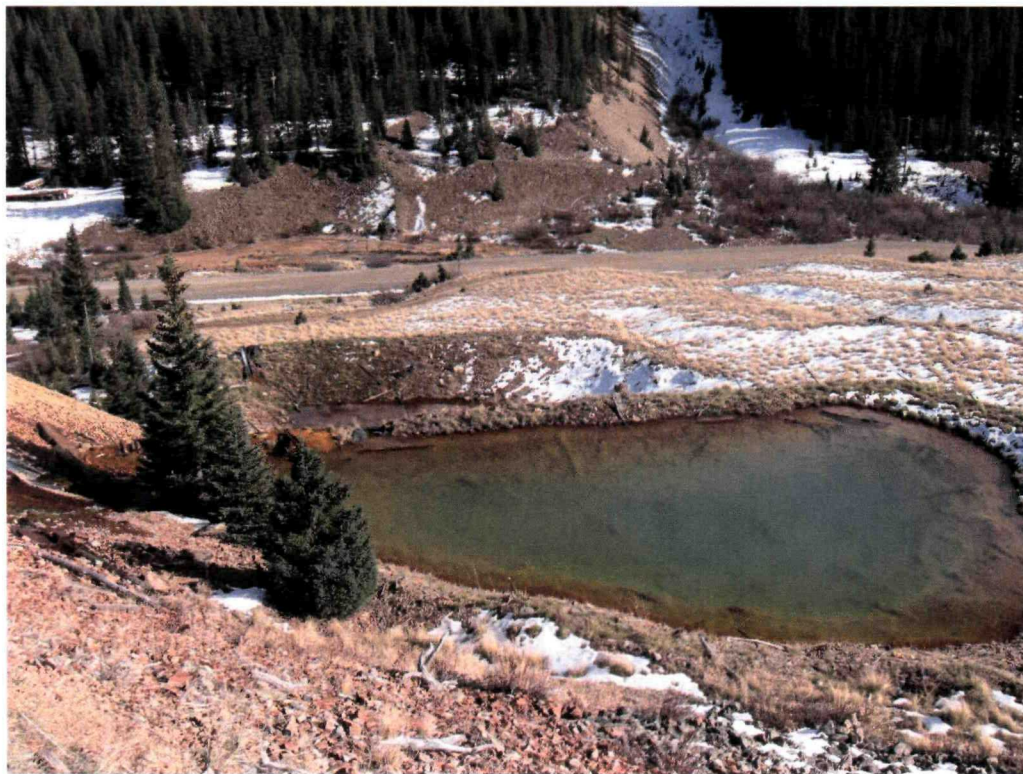
Photo 71
Mogul Mine waste piles.
